Assessment of Dam Safety of Coal Combustion Surface Impoundments

Indianapolis Power & Light Company

Eagle Valley Generating Station

Draft Report

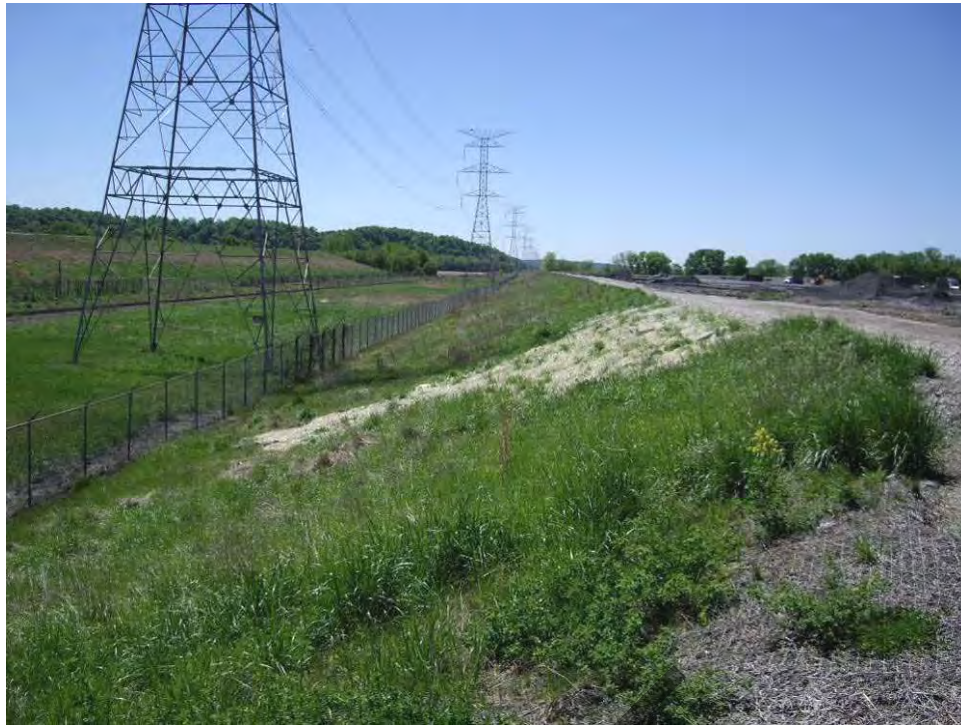
The exterior slopes of the Pond A embankments appear to be in fair condition. The exterior slopes on the north, south, east, and west embankments ranged from approximately 2.5H:1V to 3H:1V (Photos 1, 15, 20, 23, 25, 45, and 46). The exterior slope on the embankment between Pond A and Pond B (divider embankment A/B) and embankment between Pond A and Pond C (divider embankment A/C) ranged from approximately 2H:1V to 3H:1V (Photos 28, 33, 34, 38, 40, and 42).

1. Pond A – East embankment exterior slope looking south.

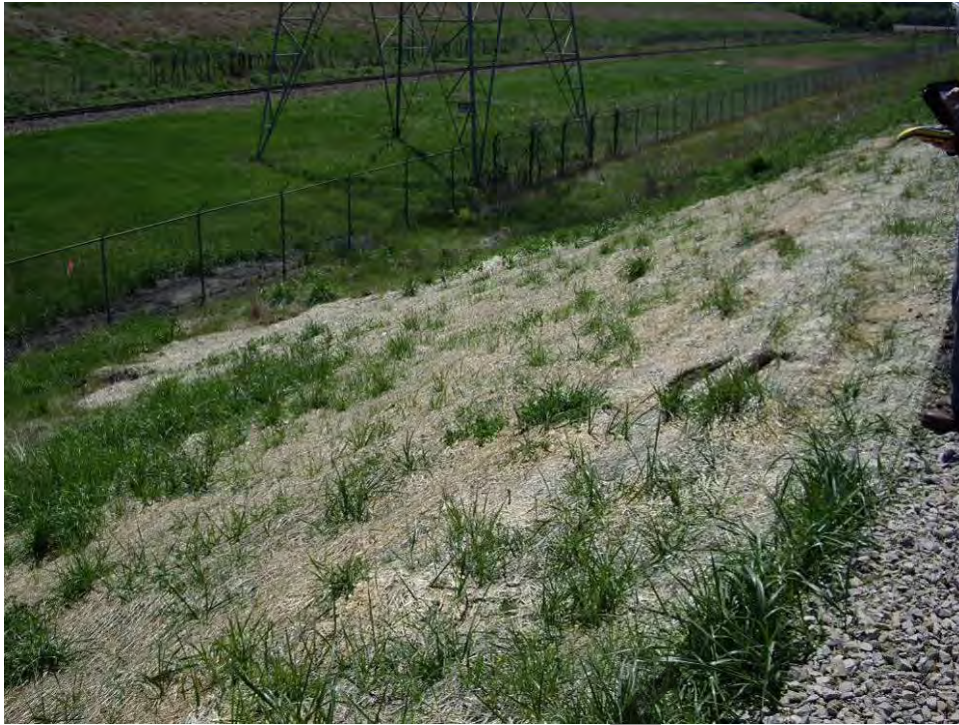
One erosion repair on the northeast corner of the east embankment was observed (Photos 1, 3, and 4). The repair consists of an erosion control blanket. The erosion control blanket did not appear to be installed consistent with typical manufacturer's recommendations. Stakes did not appear to be installed properly, and the blankets were not overlapped or keyed into an anchor trench in the slope. Approximately 1- to 3-inch gaps were observed below the blanket. Another erosion rill was observed on the west embankment (Photo 26). Some crushed stone was placed near the crest of the embankment in an effort to reduce further erosion.

3. Pond A – East embankment exterior slope. Erosion control blanket installed near northeast corner looking southeast. Note: Blanket appears to be improperly staked, there are 1- to 3-inch gaps beneath the blanket, and there is no apparent anchor trench or roll overlap.

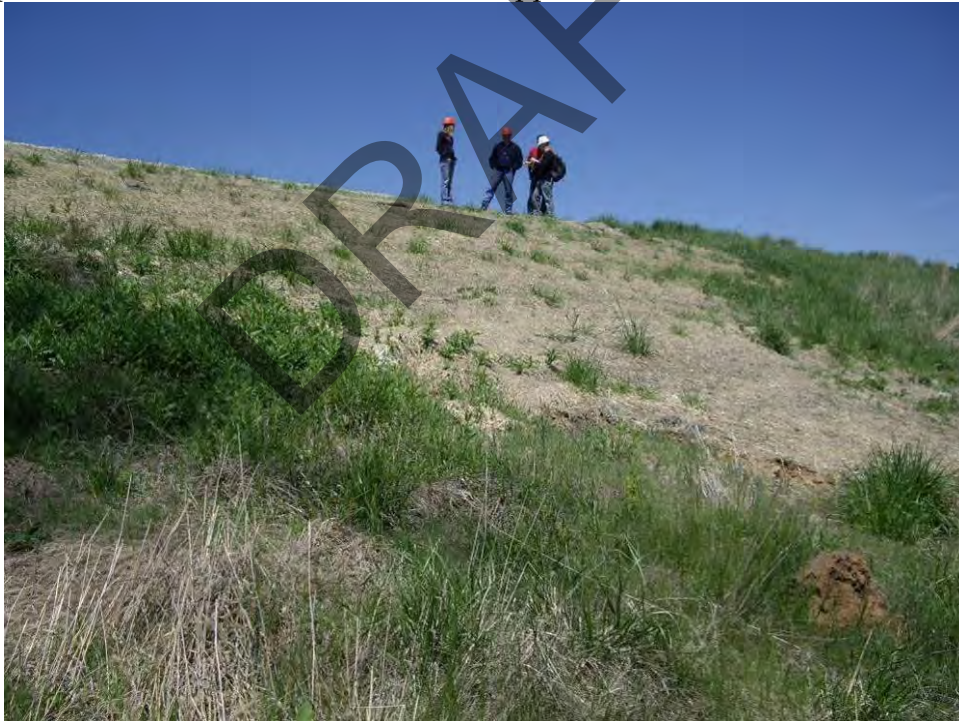
4. Pond A – East embankment exterior slope. Erosion control blanket installed near northeast corner looking northwest.

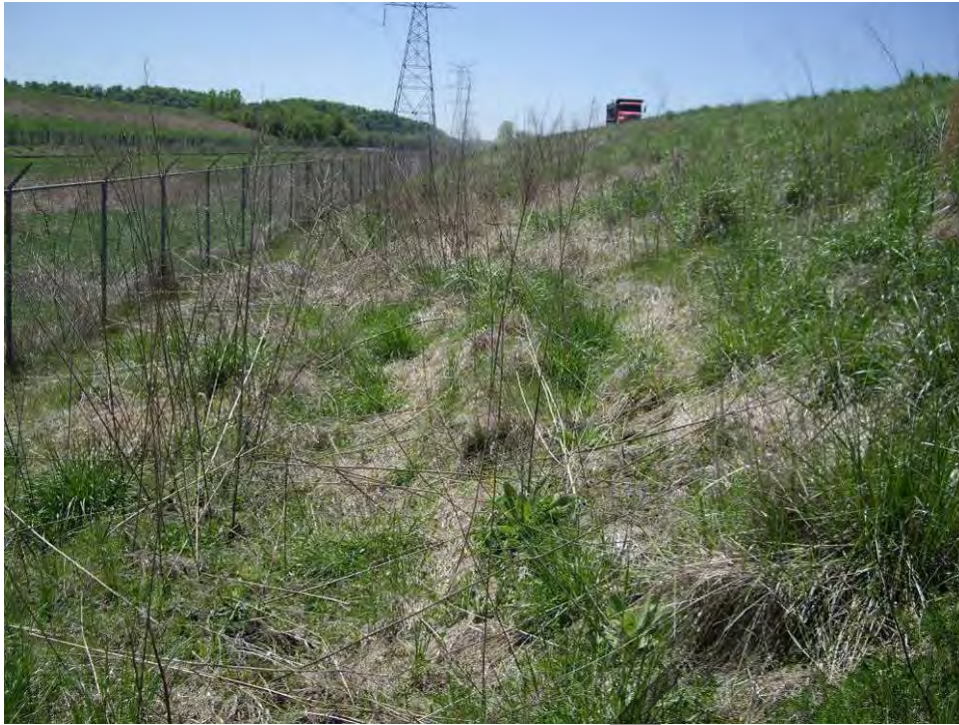
There were two low spots at the toe of the east embankment (Photo 5). At the low spots, there was also some minor sloughing. IPL stated these were low areas where a tractor had previously gotten stuck during mowing operations. A surface depression was also observed near the crest of the eastern embankment (Photo 7).

5. Pond A – East exterior slope looking south. Low spot and minor slough at toe of slope.. Possible tractor rutting.

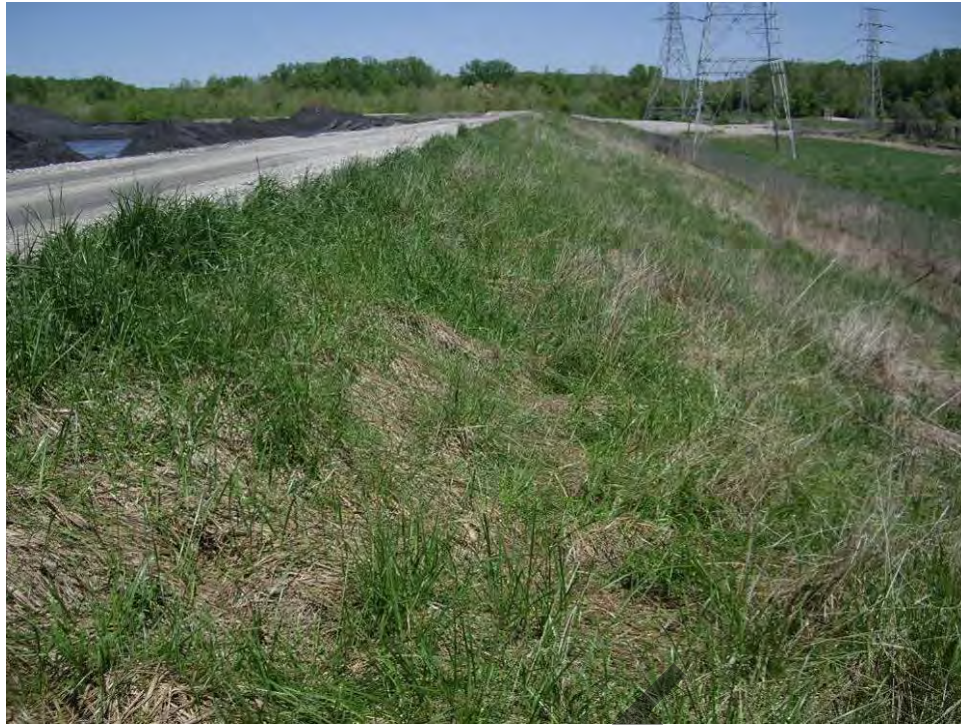
7. Pond A – depression near crest of east embankment, looking north.

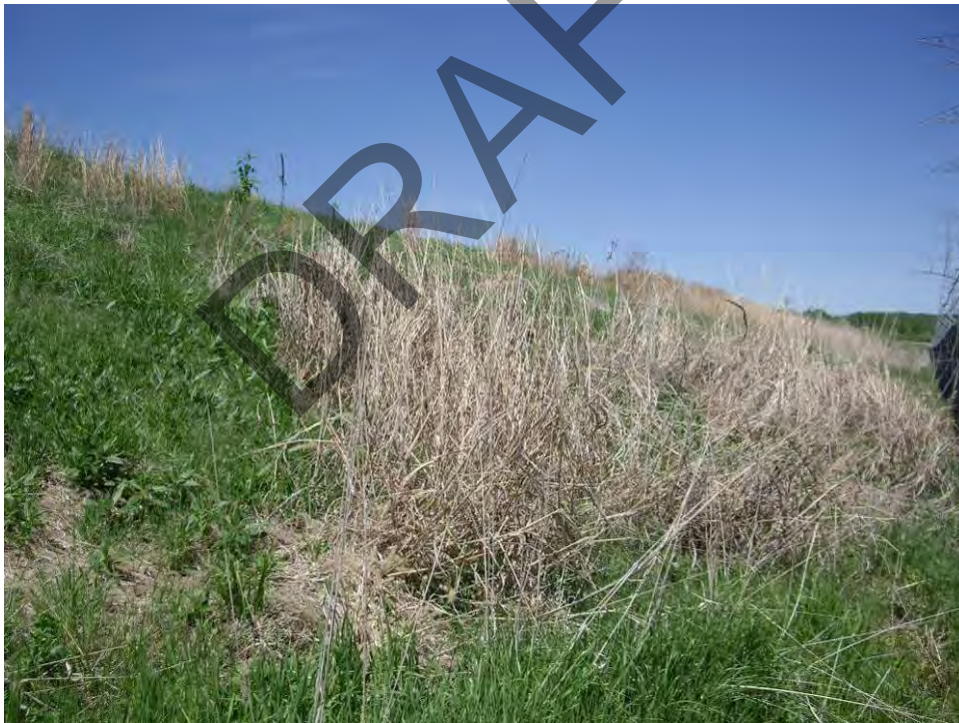
A possible former seep area was observed at the toe of the east embankment (Photo 12). A possible former seep was also observed in a soft spongy area along the toe of the south embankment (Photo 21). No active seepage was observed during the site visit. However, active seepage in these areas has been noted in previous inspection reports.

12. Pond A looking north - Possible former seep location at toe of east embankment.,.

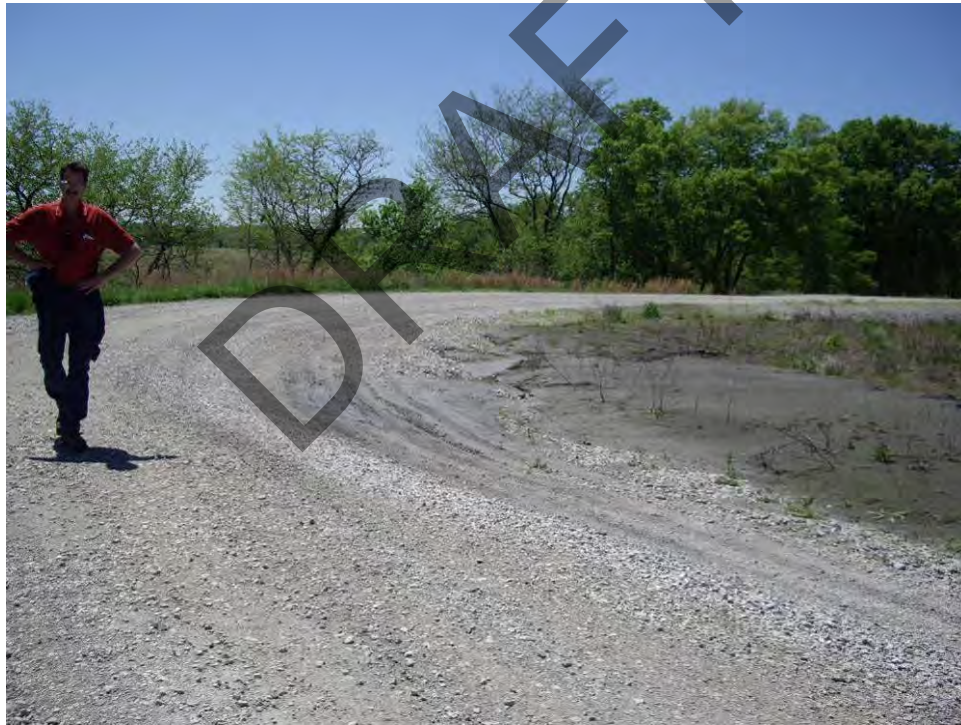
14. Pond A - Depression in crest from truck traffic, looking south.

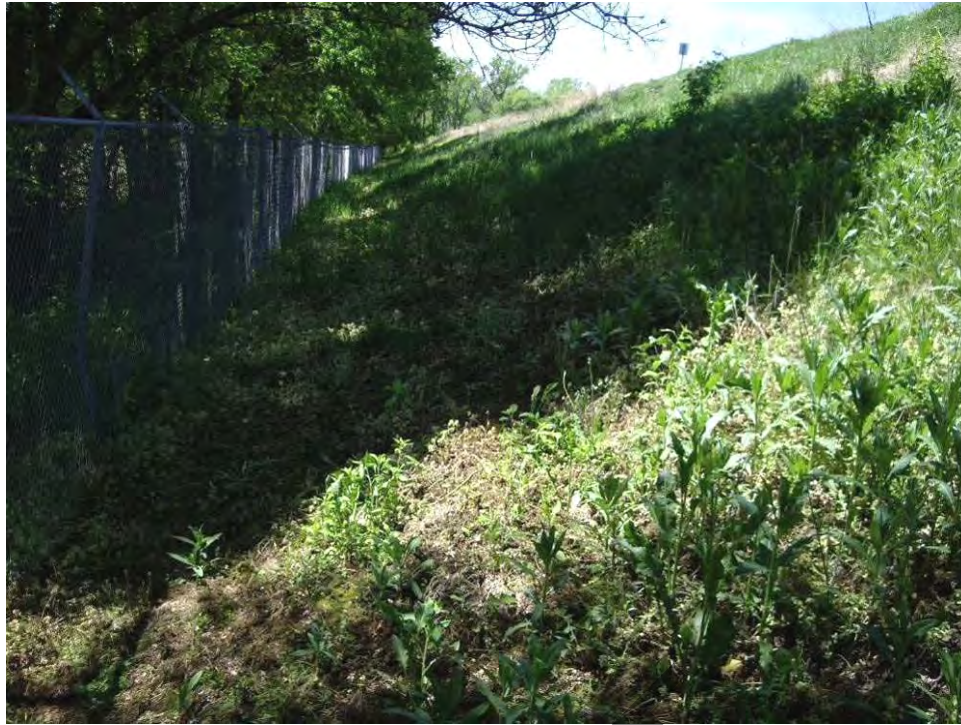
21. Pond A – Soft spongy area at toe of south embankment under tree canopy (possible former active seepage area).

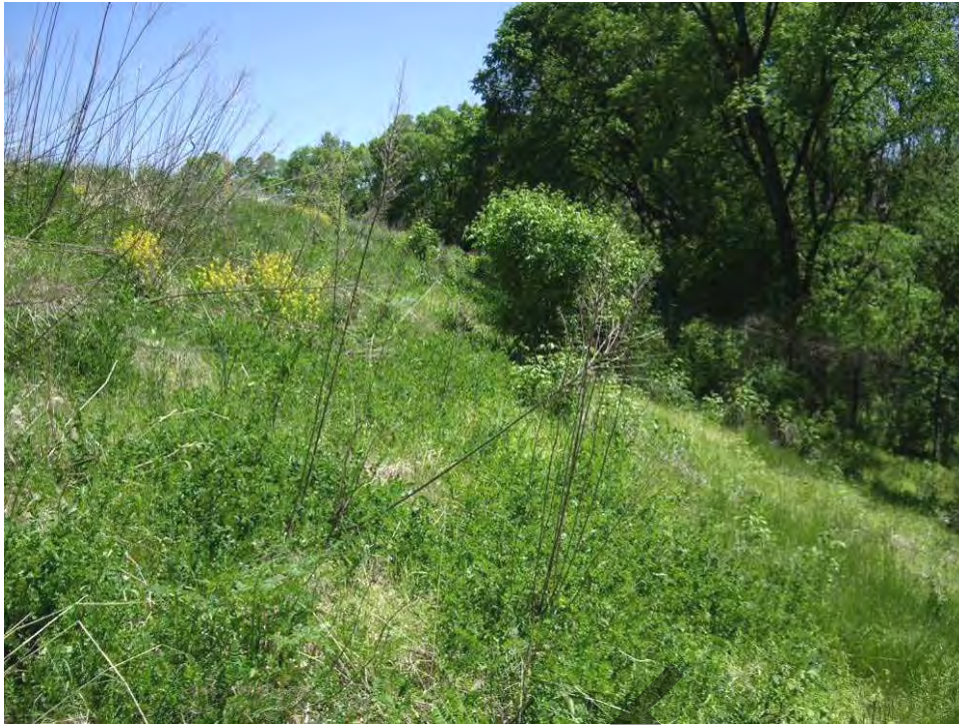
The north, south, east, and west embankments were generally covered with grassy vegetation approximately 12 to 48 inches tall. There are multiple species of grass growing on the slope from the various expansions and erosion repairs. There was some small brush on the southwest embankment (Photo 23) and one bush growing on the east embankment.

23. Pond A – South embankment exterior slope, looking southeast.

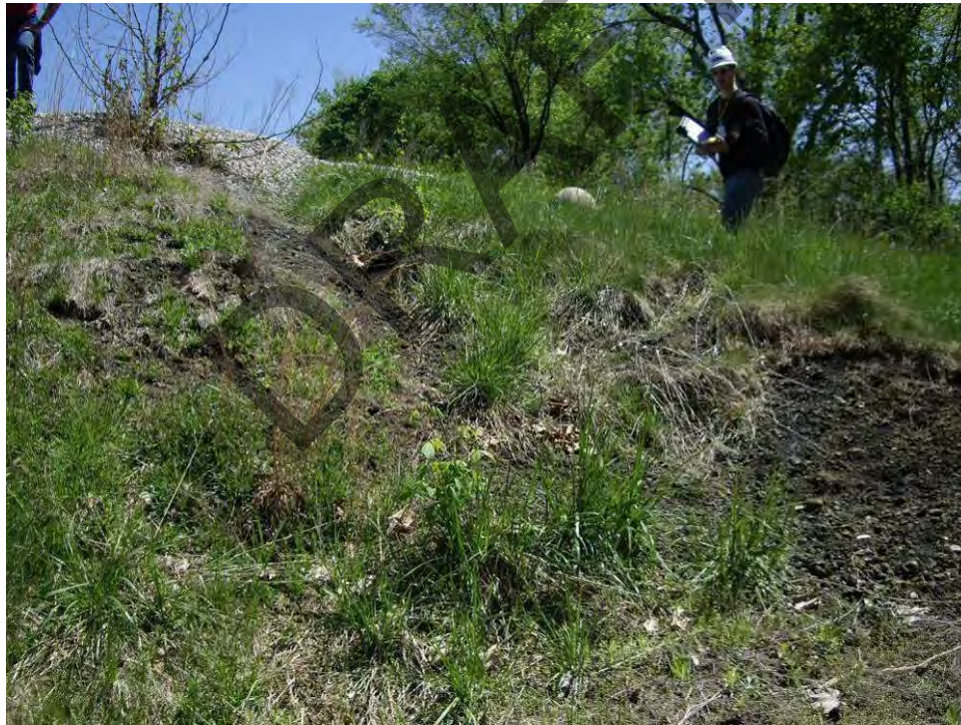
26. Pond A – Erosion rill on west embankment exterior slope, looking east.

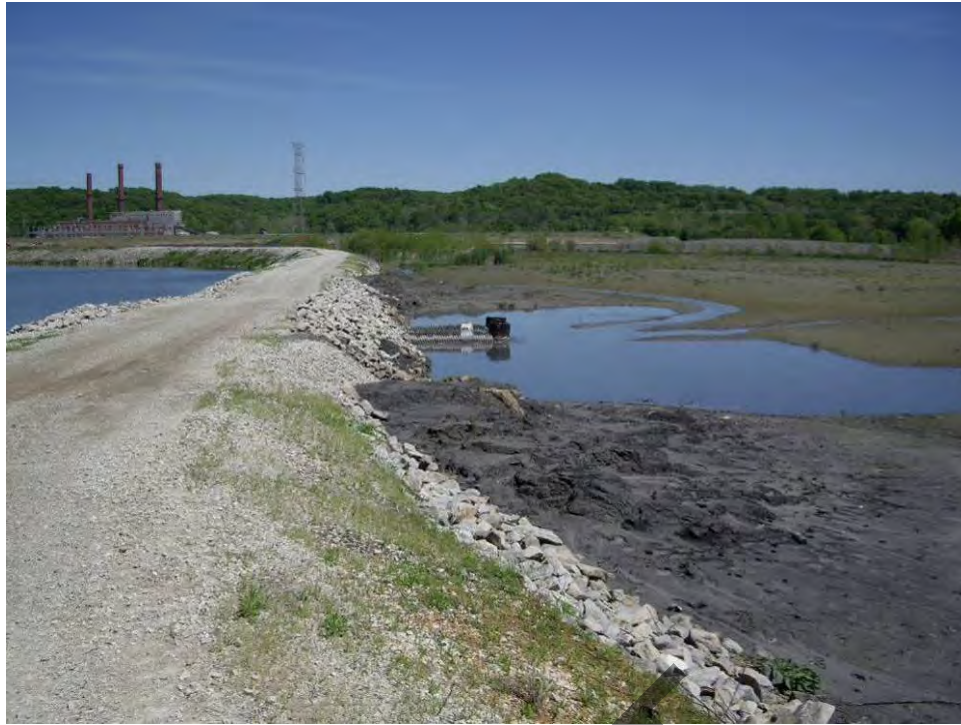
The outlet pipes in Pond A were in fair condition (Photos 28, 29, and 30). The T-connections at the inlets appear to be settling downward in most instances. The coupling at the connection between the T and the pipe may be starting to buckle from supporting the weight of the T based on observed sagging of the connection. The inlets were clean and a floating boom was wrapped around the inlets to reduce the potential for debris to clog the pipes.

29. Pond A/B - south slope of divider embankment, looking east.

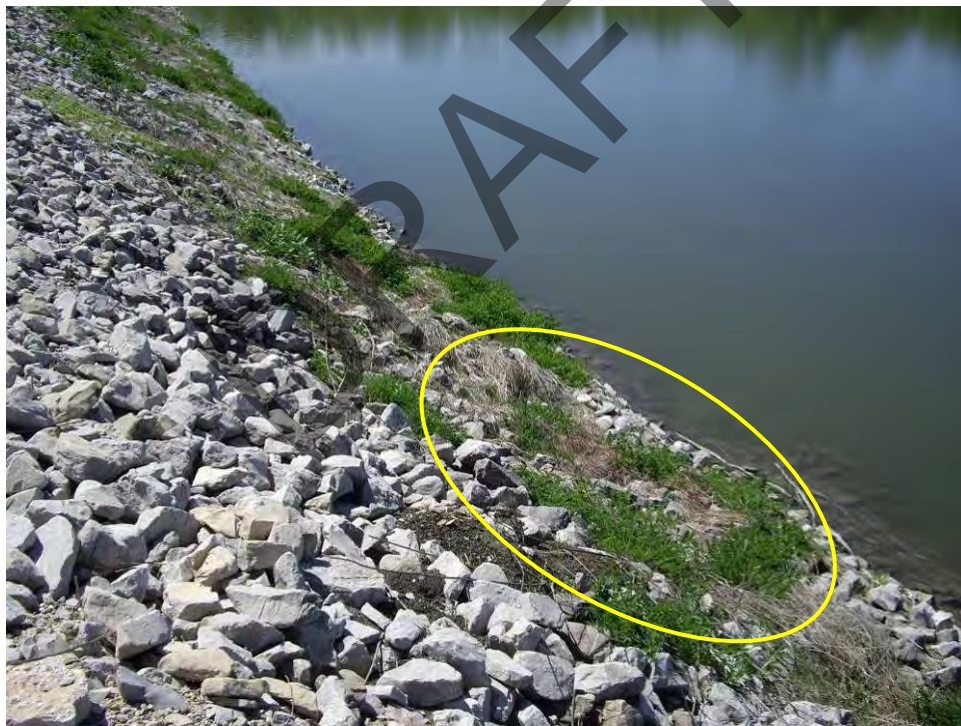
32. Depression in north slope of Pond A/B divider embankment.

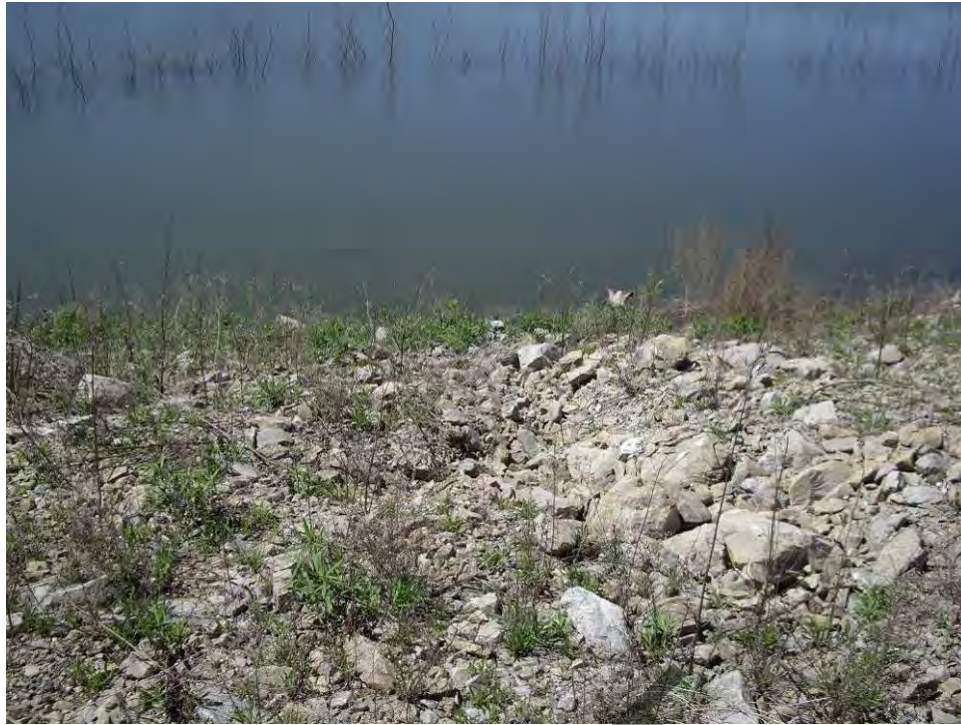
35. Erosion feature and depression in north slope of divider embankment A/B.

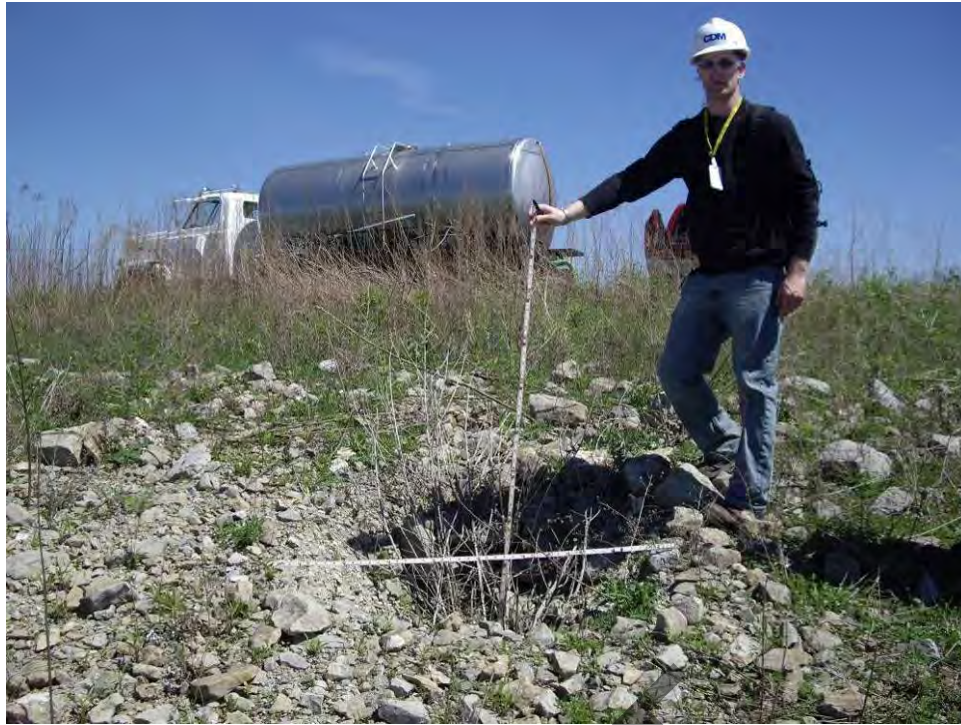
37. Depression in northwest slope of divider embankment A/B.

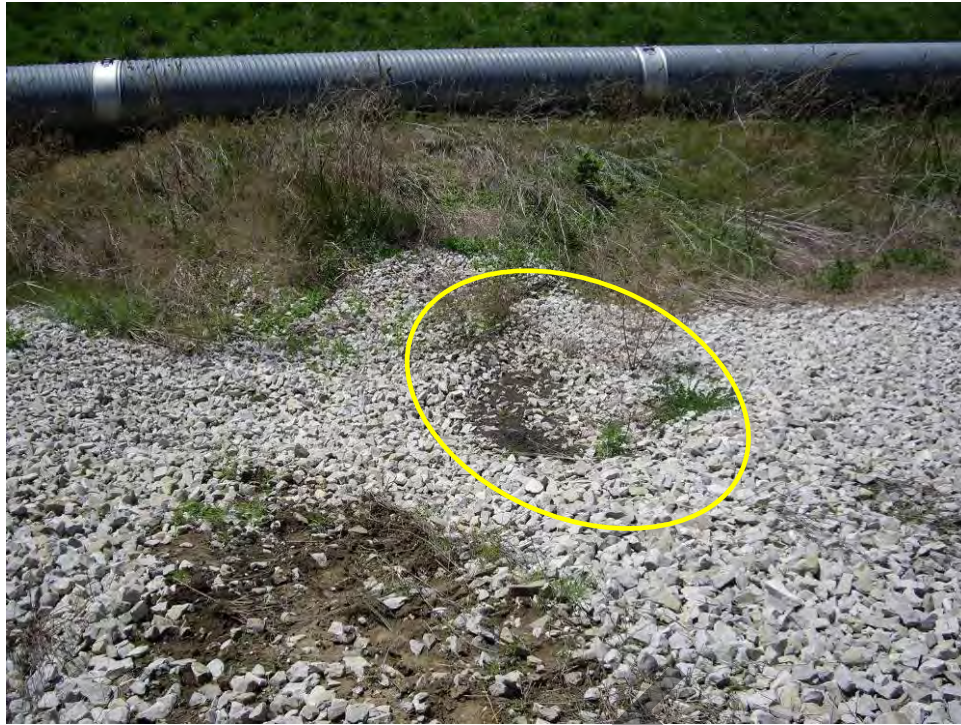
41. Minor sloughing and erosion feature on west slope of divider embankment A/C.

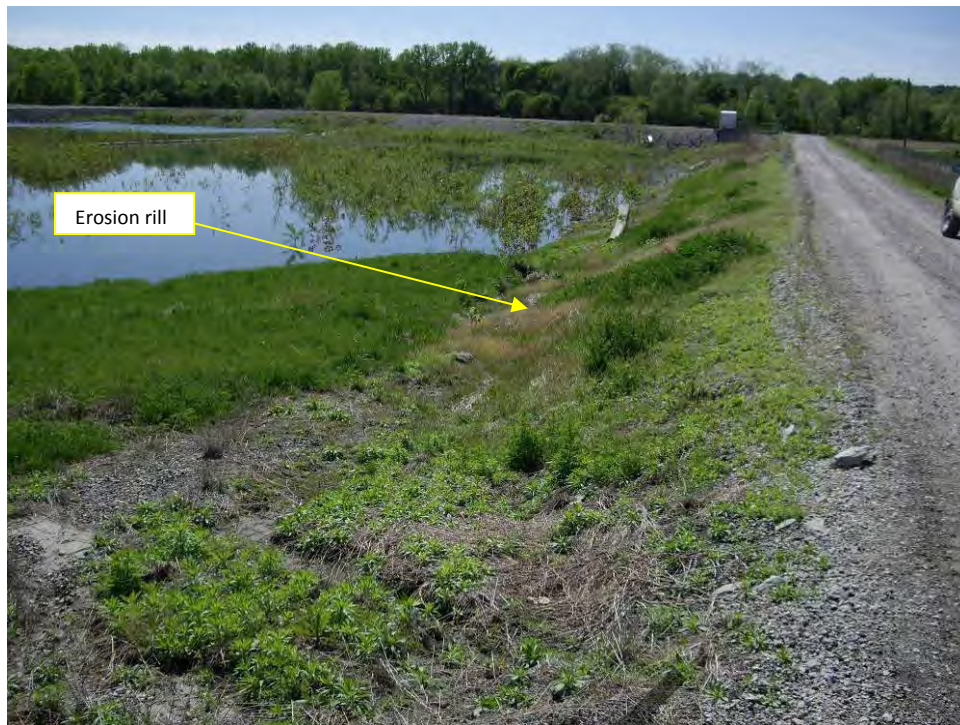
The interior slope of the Pond C embankments appeared to be generally in fair condition (Photos 47, 49, 51, and 54). The interior slopes were approximately 2H:1V. Most of the north embankment has no erosion protection or armor. There is some riprap on the north embankment near the northeast corner and at the outlet structure. On the north embankment in the northeast corner there is an erosion rill developing

47. Pond C – North embankment interior slope and crest, looking west. Note erosion rill on interior slope.

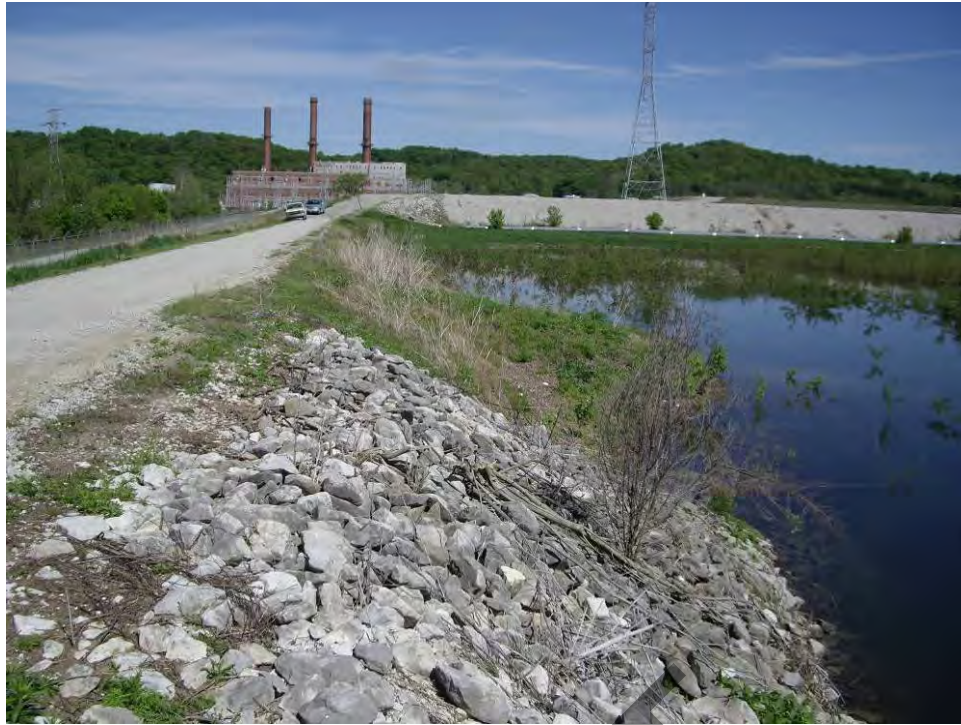
49. Pond C - North embankment interior slope, looking east. Note brush and limited riprap on slope.

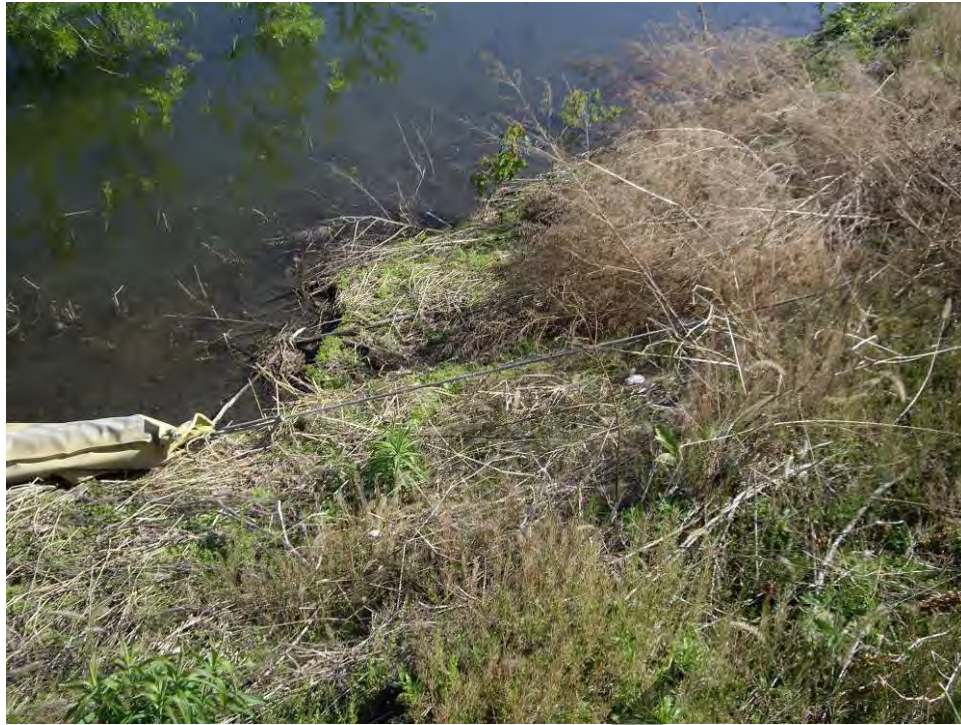
On the west embankment there are large segments without erosion protection or armor. Eroded areas on the west embankment have been repaired with crushed stone and 3- to 4-inch stone. An erosion feature from the diversion boom rope was observed on the west embankment (Photo 55).

55. Pond C - Erosion feature from diversion boom tie line.

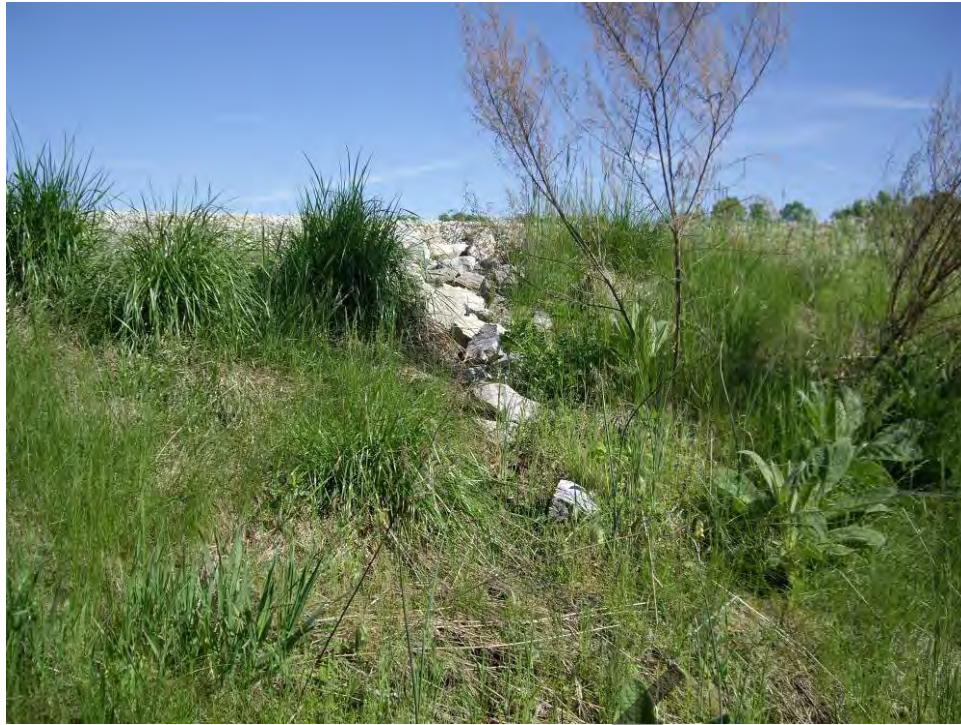
An erosion rill on the exterior slope at the southern reach of the west embankment was observed (Photo 65). The erosion rill had recently been filled with riprap to reduce further erosion.

65. Pond B - erosion rill on exterior slope recently filled in with riprap, looking east.

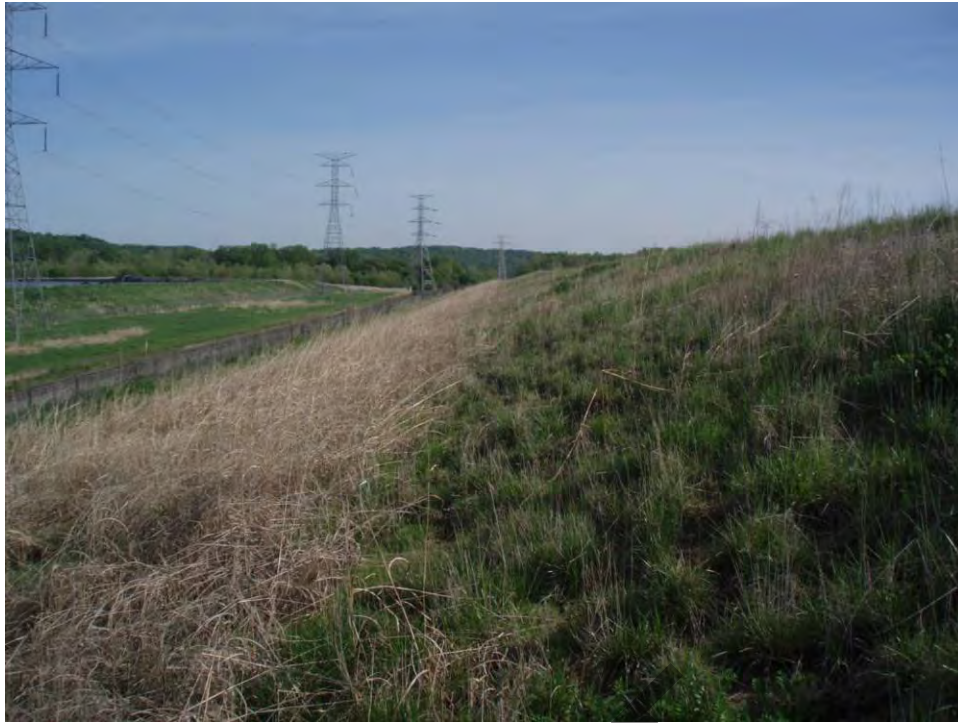
89. Pond D – West embankment exterior slope, looking north. Note bands of vegetation from the vertical expansions. Bare spots observed on upper third.

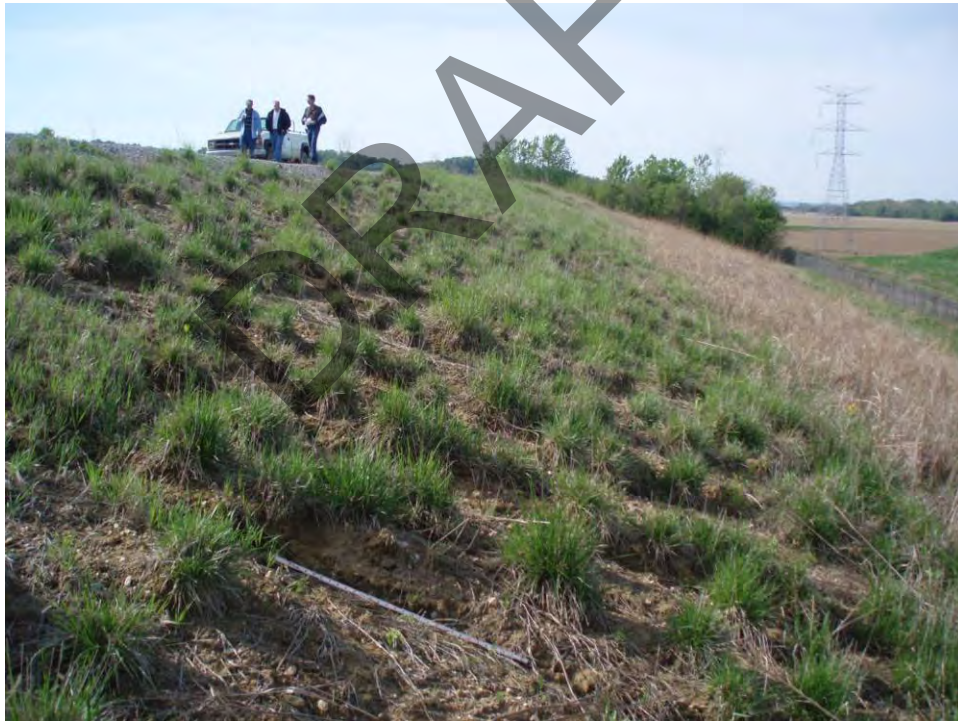
90. Pond D – Typical bare spots on upper third of west embankment exterior slope, looking south.

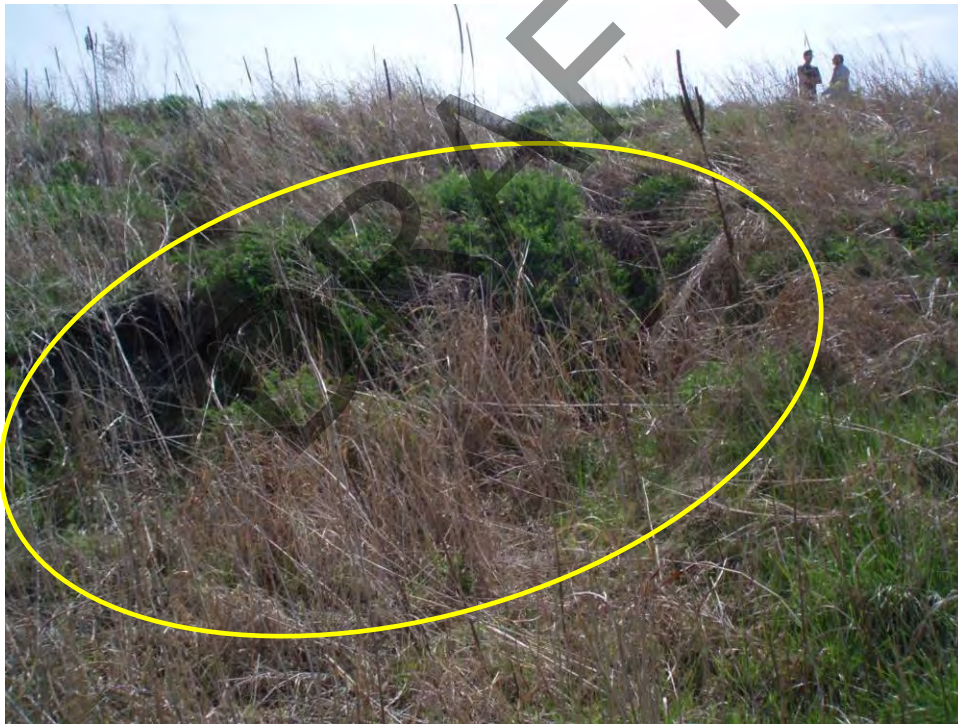
106. Pond E - 16'Wx4'Dx17'L erosion gully at toe of west embankment exterior slope from previous failure event. Note erosion is scheduled to be repaired.

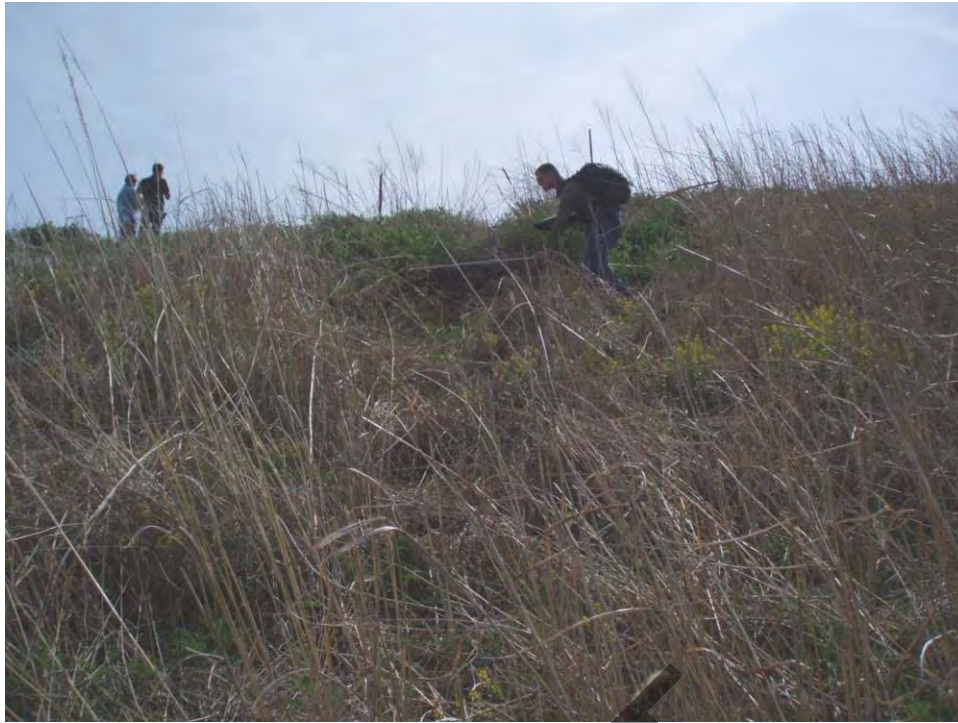
107. Pond E – 8'Wx4.5'Dx15'L erosion gulley at crest of west embankment exterior slope from previous failure event. Note erosion is scheduled to be repaired.

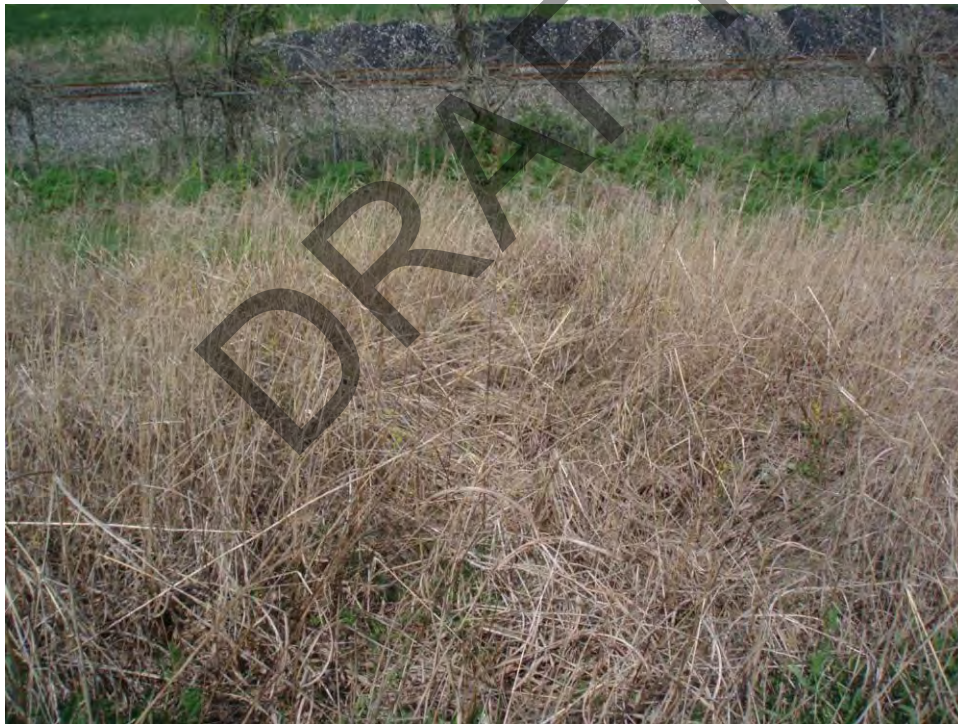
112. Pond E – 8'Wx3'Dx25'L erosion gulley at mid-slope of west embankment exterior slope from previous failure event. Note erosion is scheduled to be repaired.

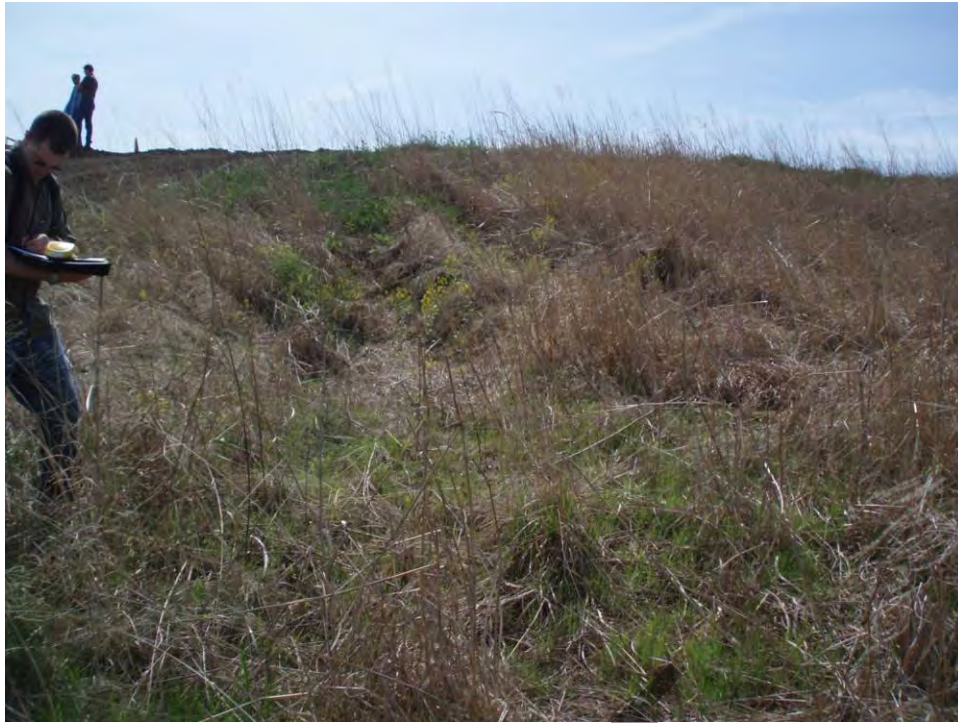
113. Pond E – two approximately 4'Wx3'Dx20'L erosion gulleys at mid-slope of west embankment exterior slope from previous failure event. Note erosion is scheduled to be repaired.

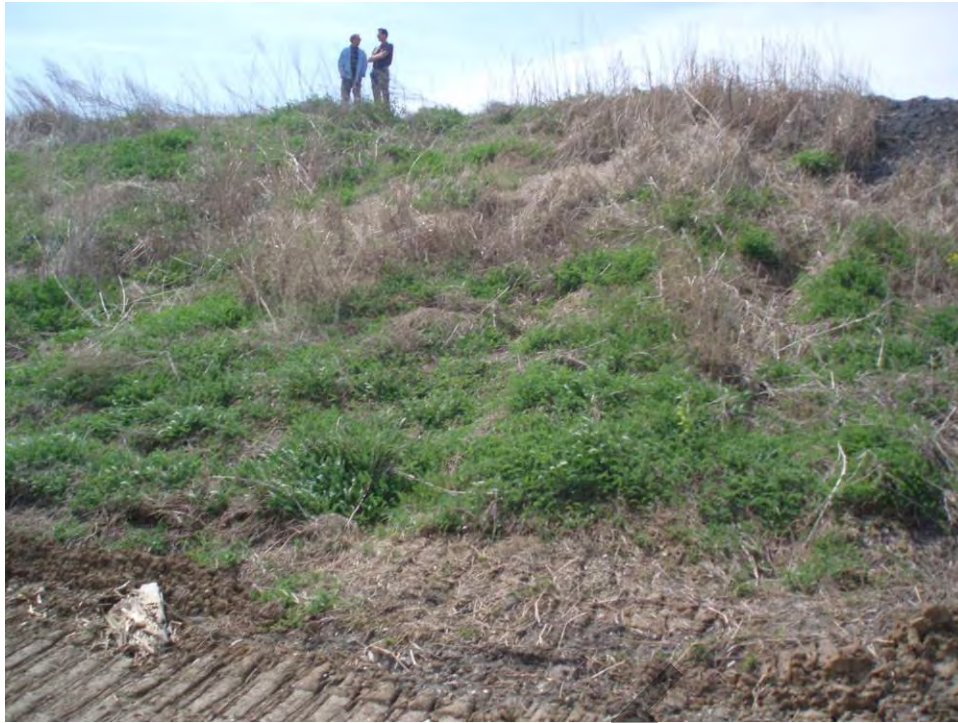
119. Pond E – erosion feature on north embankment exterior slope from previous failure event.

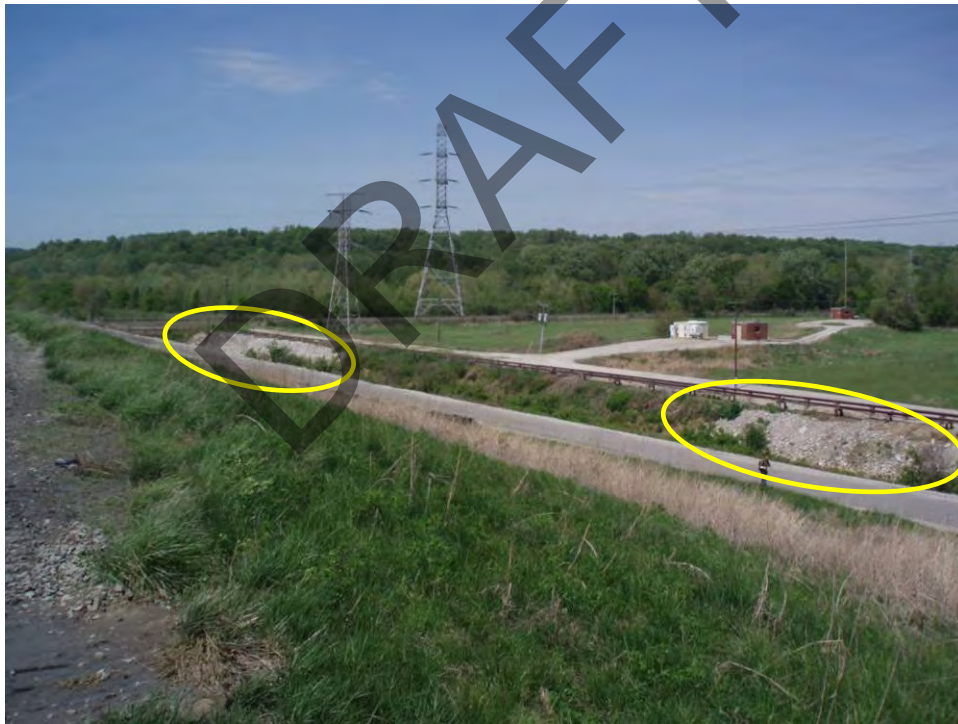
136. Overview of downstream area north of Pond D and Pond E. Note repair of erosion areas which resulted from breach.
